# Manhole Inspection Summary

Manhole # S67M\_\_010MH

**Location** Address: **Elliott St.**

Cross Street: **Demarcay Way**

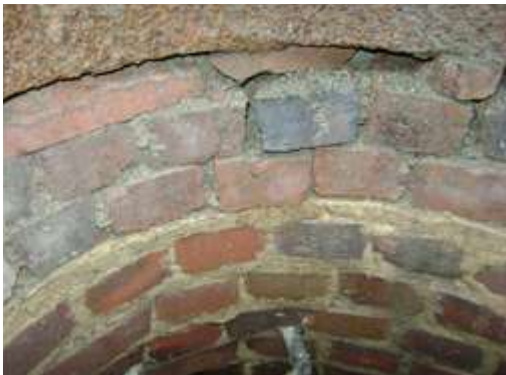
Defect 1

Condition: ☐ Sound ☐ Cracked ☐ Root Intrusion ☒ **Loose Brick** ☐ Deteriorated

Cracks in mortar at chimney frame joint

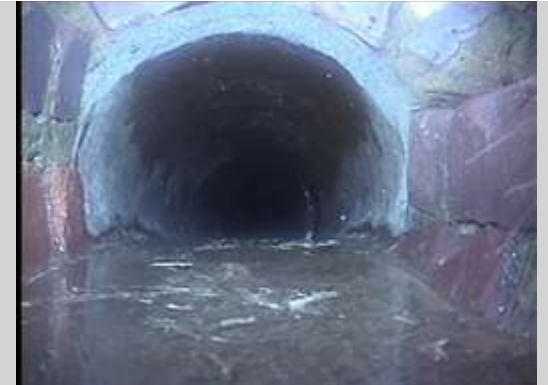
12 O'Clock Outflow

10 in. Circular Gravity Sewer  
Pipe Out @ 12 O'Clock

Pipe Height: **9.6** (in.) Rod and Bar (Angled)  
Pipe Material: **Clay** ☐ Pipe Lined  
Invert Depth: **6.58** (ft.) Flow Characteristics: **Slow**  
Deposits: ☐ None ☐ **Mud** ☒ **Stringy** ☐ Debris ☐ Grease  
Silt Depth: **2** (in.) Deposits Extent: **Heavy**  
Infiltration: **None** Pipe Seal Cond: **Sound**

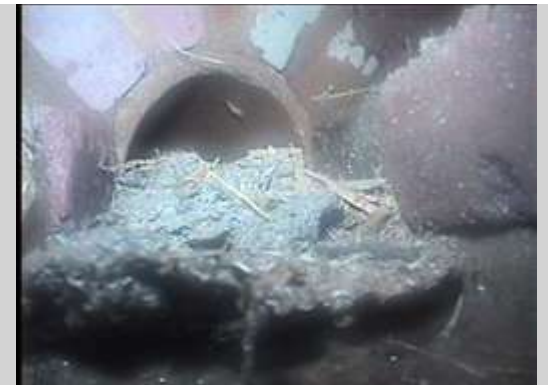
3 O'Clock Inflow

6 in. Circular Gravity Sewer  
Pipe In @ 3 O'Clock

Pipe Height: **6** (in.) Rod and Bar (Angled)  
Pipe Material: **Clay** ☐ Pipe Lined  
Invert Depth: **6.42** (ft.) Flow Characteristics: **None**  
Deposits: ☐ None ☐ **Mud** ☒ **Stringy** ☐ Debris ☐ Grease  
Silt Depth: **2** (in.) Deposits Extent: **Heavy**  
Infiltration: **None** Pipe Seal Cond: **Sound**

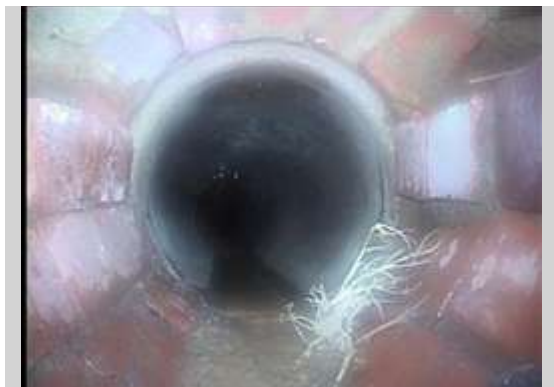
6 O'Clock Inflow

10 in. Circular Gravity Sewer  
Pipe In @ 6 O'Clock

Deposits: ☐ None ☒ **Mud** ☒ **Sludge** ☐ Debris ☐ Grease

Silt Depth: **0.5** (in.) Deposits Extent: **Medium**
